Original Kawasaki Late '72/'73 H1D/H2 CDI

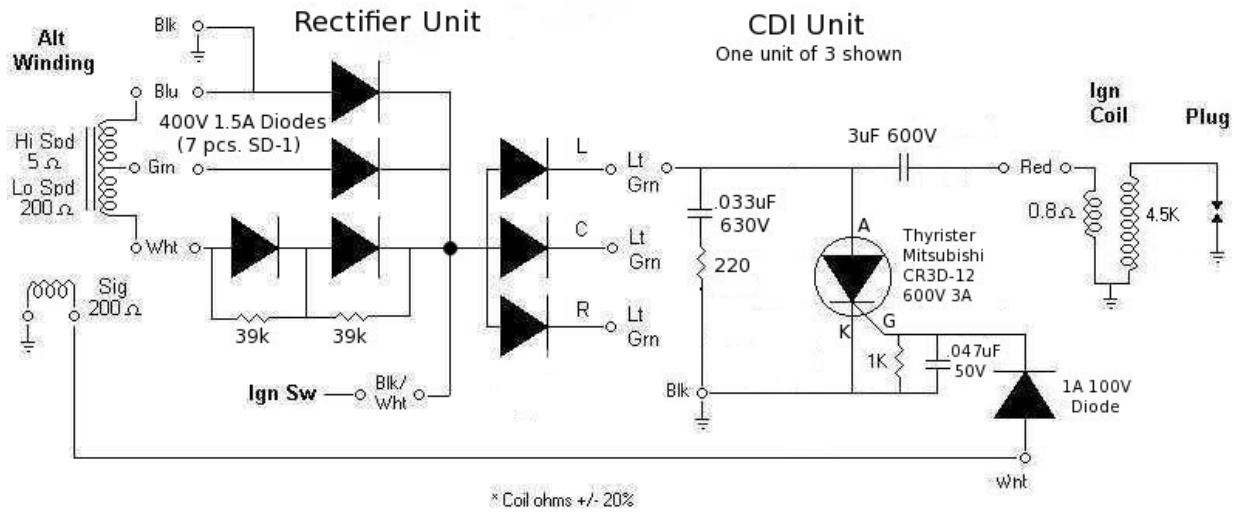
This is the schematic of original rectifier and CDI boxes from late 1972 and 1973 (at least). Early 1972 units had a .047 microfarad capacitor instead of the .033 uF one shown. There may have been other minor differences. All of the units from this era that I own have failed. Sometimes the .047 uF capacitor shorts, and causes the 220 Ohm resistor to burn up, often in a spectacular way. Other failures are possible, including failure of the Thyristor (SCR). If this shorts, current from the alternator is conducted to ground, causing lack of spark in all three cylinders, until the bad unit is replaced. If your ignition fails in all three cylinders while you're on the road, you can try unplugging the green wires from the rectifier box to each of the three CDI boxes, one at a time. You might find that you can get the engine running on two cylinders.

I have measured the capacitance of several of the main 3uF capacitors in old units. They typically measure around 2uF, and one measured about 1.7uF. I assume that they originally were within spec, so it appears that they are degrading with age.
